Protective Glazing: The Conflict Between Energy-Saving and Conservation Requirements

Sophie Wolf*, Stefan Trümpler, Karim Ghazi Wakili, Bruno Binder, Ernst Baumann

**RECENT ADVANCES IN GLASS,
STAINED-GLASS, AND
CERAMICS CONSERVATION 2013**

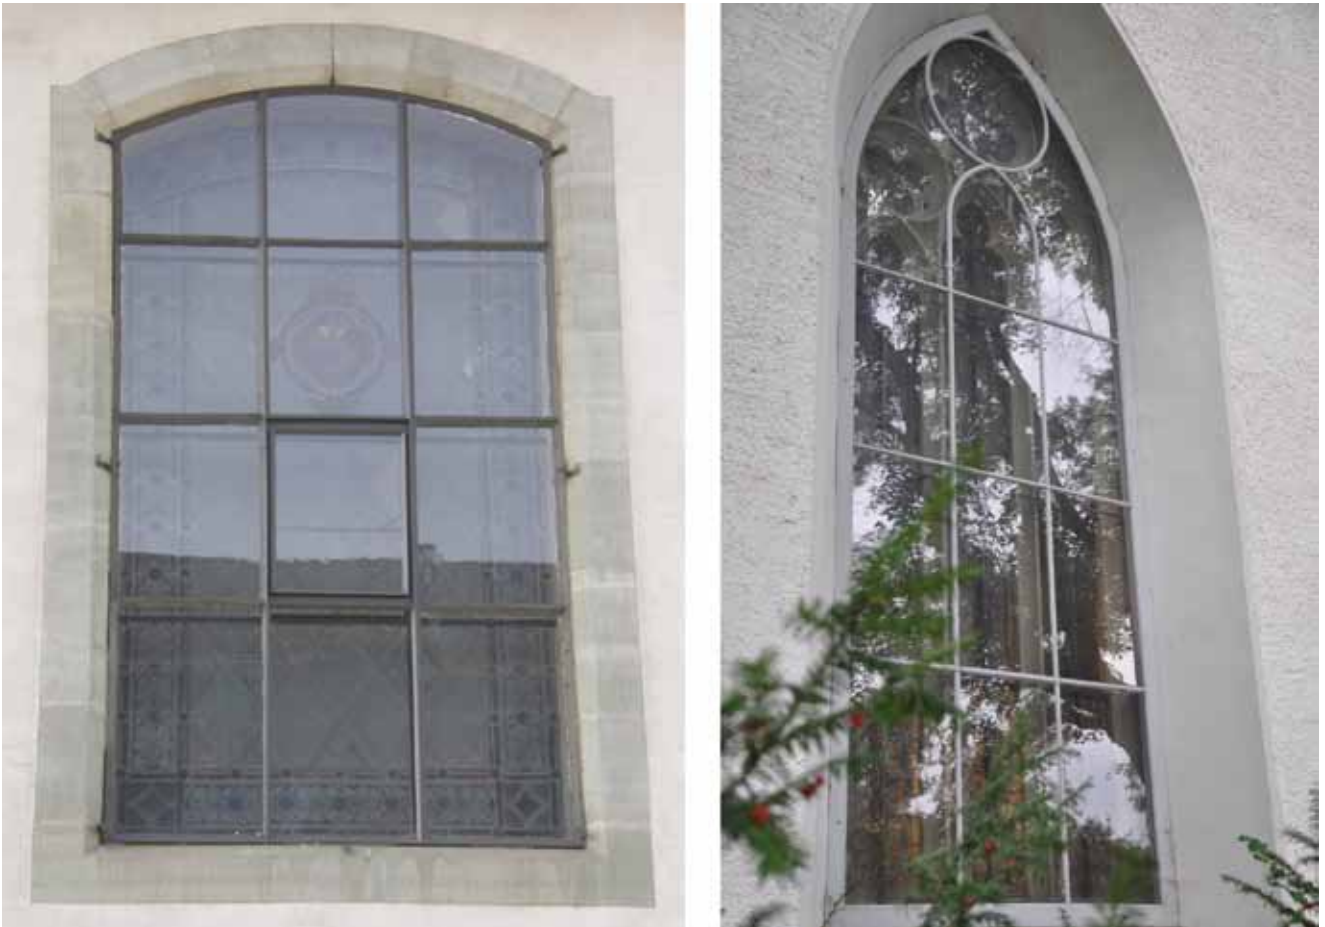
Fig. 1. Unventilated protective glazing fitted in a metal or wood frame: 'Église des Capucins' in Romont, installed around 1950 (left); Parish church of Frauenfeld-Oberkirch, installed probably before or around 1900 (right). Photos: authors.

One type of protective glazing with which the Vitrocentre Romont has been confronted in recent years (in connection with restoration and monitoring projects) is a system that was prevalent in the 1950s or even earlier. This type of protective glazing is fitted in a metal or wood frame to the window's reveal (i.e. the masonry adjoining the window) and is not connected structurally to the historic window (figure 1).

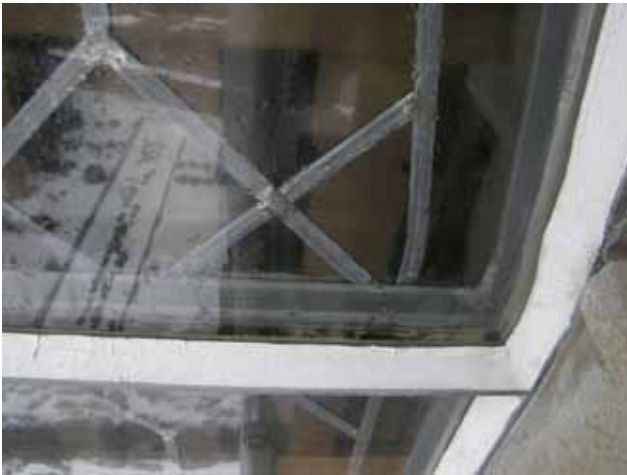
Fig. 2. 'Bonded' protective-glazing system: stained glass fitted in a metal frame together with the protective glazing, installed around 1970. Photo: authors.

Another type of protective glazing became common in the second half of the twentieth century. Here, the stained glass is fitted in a metal frame together with the protective glazing to form a new type of 'bonded' glazing; the interspace between the stained glass and the protective glazing glazed with a single glass sheet is usually less than 4 cm and normally unventilated. This leads to condensation on cold surfaces in the interspace: in winter on the inner side of the protective glazing, and in summer on the outside of the stained glass and the lead comes (figure 2). Another problem associated with these 'bonded' systems is that structural changes have to be made to the historic windows. For example, the stained glass has to be trimmed to fit the new frame, and historic armouring usually has to be removed. Finally, a type of protective glazing that has found increasing use since the 1980s consists of unventilated systems that combine the stained glass with double-glazed units (figure 3). Practical experience shows that the fitting of such sys-

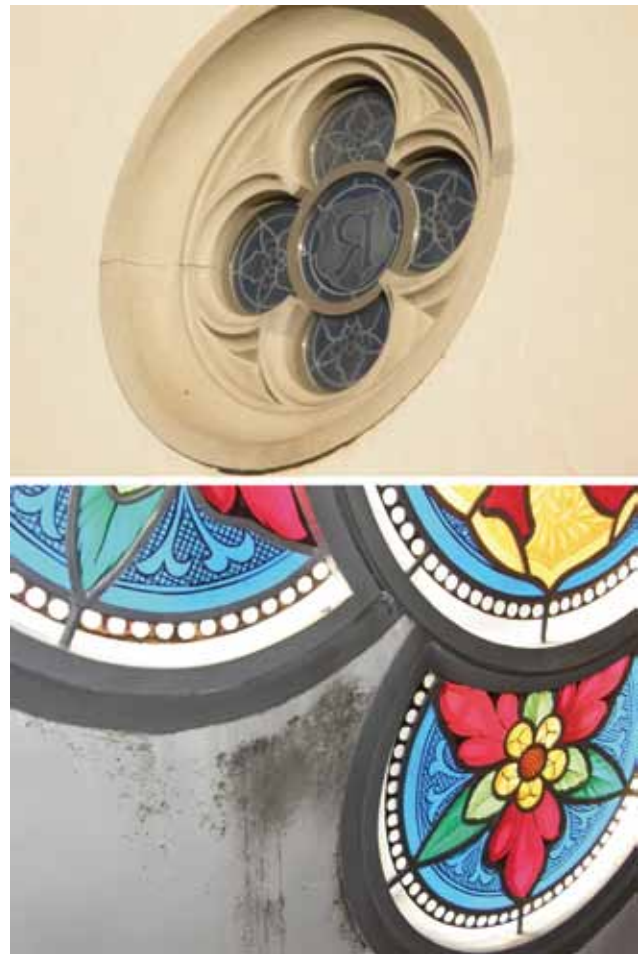
Fig. 3. Protective glazing fitted with a double glazing unit: outside view (above) and inside view showing fungal growth on the walls surrounding the stained-glass window (below). Photos: authors.

tems does not solve but only shifts the problem of condensation. Under certain climatic conditions, water condenses not on the glass surfaces but on the frames and cold wall surfaces adjacent to the windows. If the water is not properly drained, it can lead to damage and fungal growth (figure 3, bottom picture). In some cases, the double glazing creates quasi 'hermetic' conditions, which, in contrast to the originally permeable stained-glass windows (which often included little vent windows), can lead to climatic conditions that are detrimental to the interior of the church (affecting woodwork, wall paintings, organ, etc.). One variant of such a double-glazed protective glazing is the so-called 'sandwich glazing', which involves the stained glass being fitted between the two panes of a double-glazed unit (figure 4). The main problem with this system is the limited durability of the materials used in the double glazing.

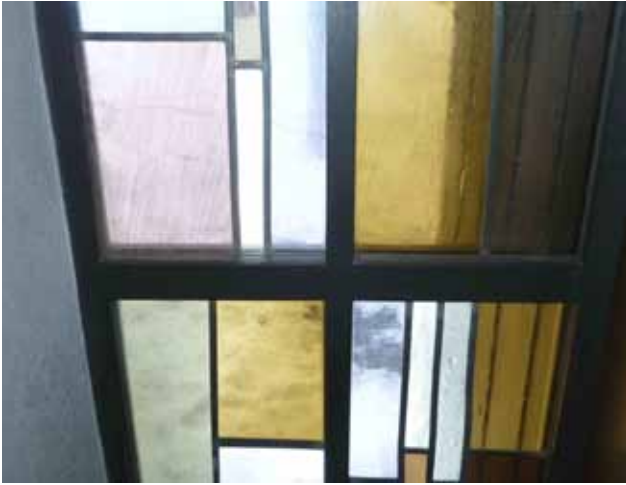
Fig. 4. Type of double-glazed protective glazing known as 'sandwich glazing', installed around 1990. Photo: authors.

Over the years, the silicone sealing begins to leak, leading to condensation on the stained glass.
